<u>Case Study</u>: How to Diagnose and Solve BACnet MSTP Connection Problems on a FieldServer

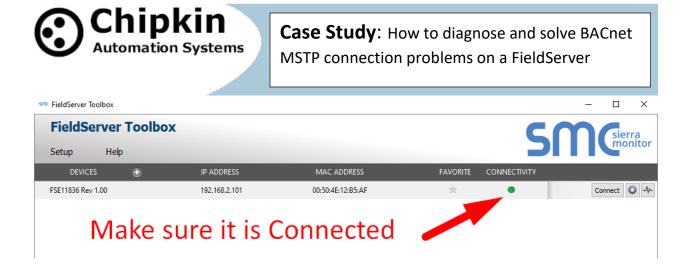
C:\WINDOWS\sys	tem32\cmd.exe - ru	uinet -i192.168.1.1	168		_		×
Connection Overview							^
Connection	Protocol	Tx Msg	Rx Msg	Tx Char	Rx Char	Errors	Ľ
01- N1 02- R2 B/ 03- N1 04- N1	SMT ACnet_MSTP XML-HTTP JSON_TCP	99,115 1 0 757	99,116 4 0 0 757	3,310,348 4 14 0 323,550	3,706,294 0 0 62,845	0 0 2	
(eys: <r>eset <nn> Goto</nn></r>	Connection					< ESC	>
<						2

In the screen capture (top) we see these numbers:

Tx Msg = 1, Tx Char = 14

This means that the FieldServer is properly transmitting data.

However, look at these numbers:

Rx Msg = 0, Rx Char = 0

This shows that zero messages are being received into the FieldServer, through BACnet MS/TP. This is a classic symptom of the MSTP connection failure. Tx Messages are being transmitted, but there are no Rx (response) Messages being received.

Solution: Check your BACnet MSTP wiring into the FieldServer. Try changing the + and – wires and test again. If this does not fix the solution, try one of the other solutions below.

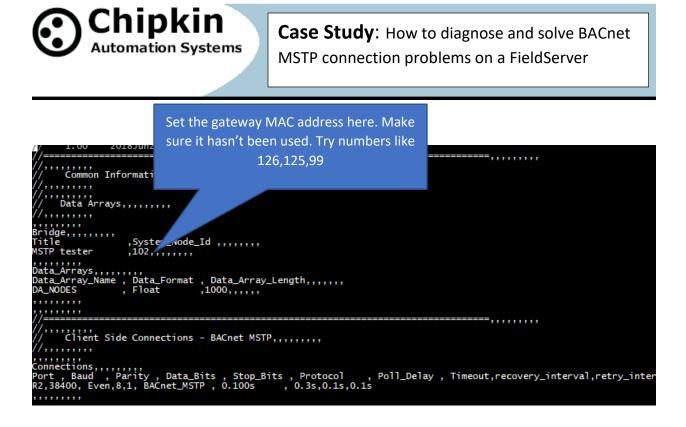
Problem #2: Duplicate MAC Address

In the config file, a System_Node_ID is where the MAC Address of the FieldServer device can be set. However, if it happens to be the same MAC address <u>as any other device</u>, the token will not pass well.

Solution: Set the MAC address of the gateway to an unlikely number (< 127). Zero and one are often used, so try 126 for your gateway.
